ASK 13

**Flight- and
Maintenance Manual**

Flight - and Maintenance - Manual
for the Glider
AS - K 13

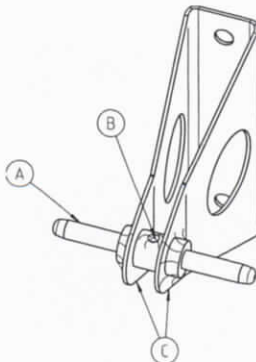
Fig. 1

Bei einem Segelflugzeug wurde festgestellt, daß die Achse (A) des Höhenruderlagers lose war. (siehe Fig. 1)

Die Achse ist in einer Buchse geführt. Durch ein Loch (B) in dieser Buchse ist sie festgeschweißt. Diese Verbindung hat nicht mehr bestanden.

On one glider it was found, that the axis (A) of the central support of the elevator was loose. (see fig. 1). This axis is supported in a bushing. Through a hole (B) in this bushing, the axis is fastened by a weld. This welded connection did not exist any more.

Das Höhenruder demontieren. Prüfen, ob die Lagerachse (A) fest sitzt.
Dabei sind zusätzlich auch die Bleche des Lagerbocks rund um die Schweißnähte (C) auf Risse zu prüfen (mindestens mit einer Lupe 10facher Vergrößerung).
Gegebenenfalls ist der Lagerbock zu ersetzen.
Diese TM ist als Anhang in das Flug- und Betriebshandbuch einzufügen und im Berichtsstandsstand einzutragen.
*Unmount the elevator. Inspect the axis (A). It must have a firm seat.
At that occasion, the sheet metal of the support is to be checked for cracks around the welds (C) (at least with a 10x magnification loupe).
When indicated, the support must be replaced.
This copy of the Technical Note must be inserted in the Flight and Operations Manual of the respective glider as an annex, and a corresponding entry must be made into the "Amendments to the Manual"*

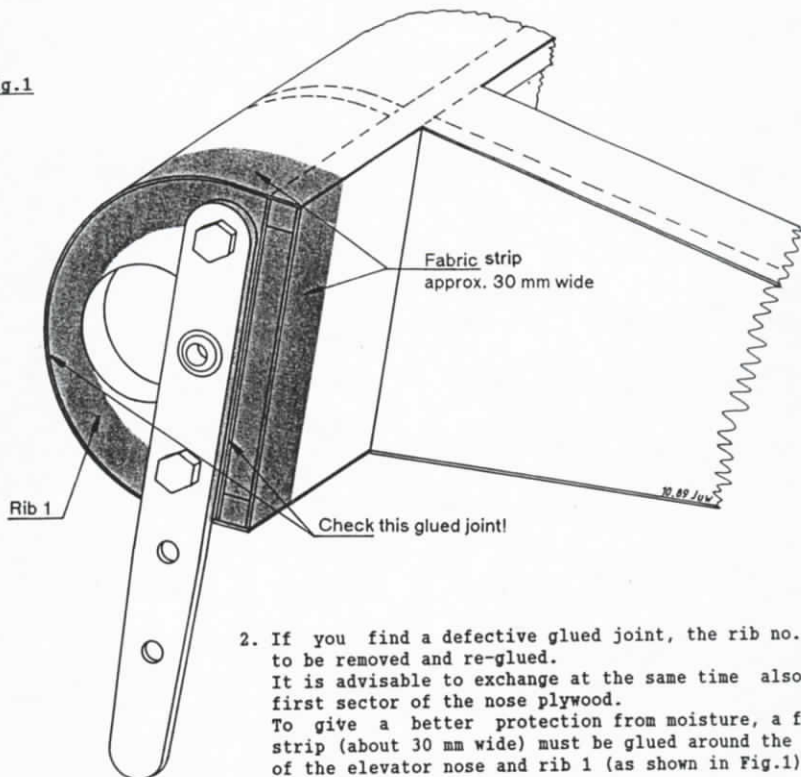
Fig.1

A glider of the model K7 failed to gain normal flight attitude immediately after tow rope release on winch launch. With the stick full back only the left elevator could be actuated in the correct direction; the right elevator deflected downwards. The reason for this was a loose glue bond at the elevator rib 1 at which the elevator fitting is attached. Similar incidents lead already before to the issue of the LTA 72-7 dated Feb.9,1972.

1. Remove elevator.
Check that the glued joint between rib 1 and the leading edge plywood and the elevator spar respectively is in good condition (see Fig.1). Before doing so check whether the LTA 72-7 of Feb.9, 1972 was already previously accomplished (this is not applicable to K9, K11 and ASK 18); if yes then the fabric strip first carefully has to be detached in order to be able to check the glued joint.

2. If you find a defective glued joint, the rib no.1 has to be removed and re-glued.

It is advisable to exchange at the same time also the first sector of the nose plywood.

To give a better protection from moisture, a fabric strip (about 30 mm wide) must be glued around the edge of the elevator nose and rib 1 (as shown in Fig.1).

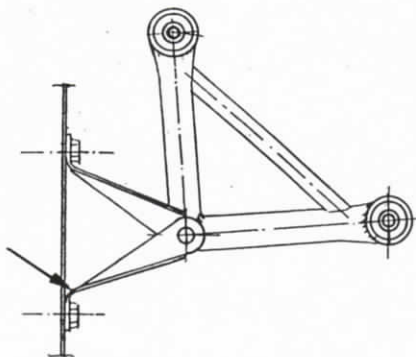
On some gliders of the model ASK 13 the bearing brackets of the airbrake control circuit have broken at the wing root rib. The failure was caused by too high toggle forces which resulted from a wrong adjustment of the toggle in the airbrake control circuit.

1. Carefully inspect the bearing brackets of the airbrake control circuit at the wing root ribs as well as the root ribs themselves for damage, cracks etc. In case of doubt the paint must be removed off the bracket. In most cases the breaks were found at the bottom of the front bearing bracket; refer to the drawing on Sheet 2 of this TN !
Where damages at one bearing bracket are found, this part must be exchanged; where a root rib is damaged, it requires repair.

- 3.4 Take care that the toggle must not go over the dead point which would cause the airbrakes to extend again.
- 3.5 For both airbrakes together, the hand forces must not exceed approx. 6 daN, when measured at the front airbrake operating lever from above.
- 3.6 Re-fit the airbrake return spring at the front operating lever in the cockpit.
4. This Technical Note must be inserted as appendix into the ASK 13 Flight and Maintenance Manual and this action must be entered into the "Amendments" on page 2.
5. The inspection of the bearing brackets and of the toggle force of the airbrake control circuit (as described under points 1. thru 3.) must be included from now on within each annual C. of A. inspection.
