ASK 13

**Flight- and
Maintenance Manual**

Flight - and Maintenance - Manual
for the Glider
AS - K 13

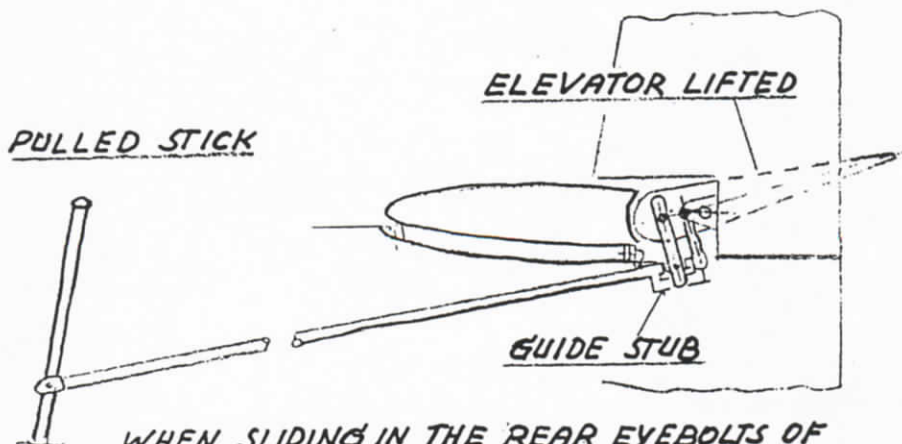
WHEN SLIDING IN THE REAR EYEBOLTS OF THE STABILIZER IT IS ADVISABLE TO LIFT THE ELEVATOR SOMEWHAT. THE BALL BEARING OF THE ELEVATOR CONTROL LEVER MUST FIT INTO THE GUIDE STUB OF THE PUSH-PULL TUBE TO AVOID THE RISK OF BENDING THE TUBE.

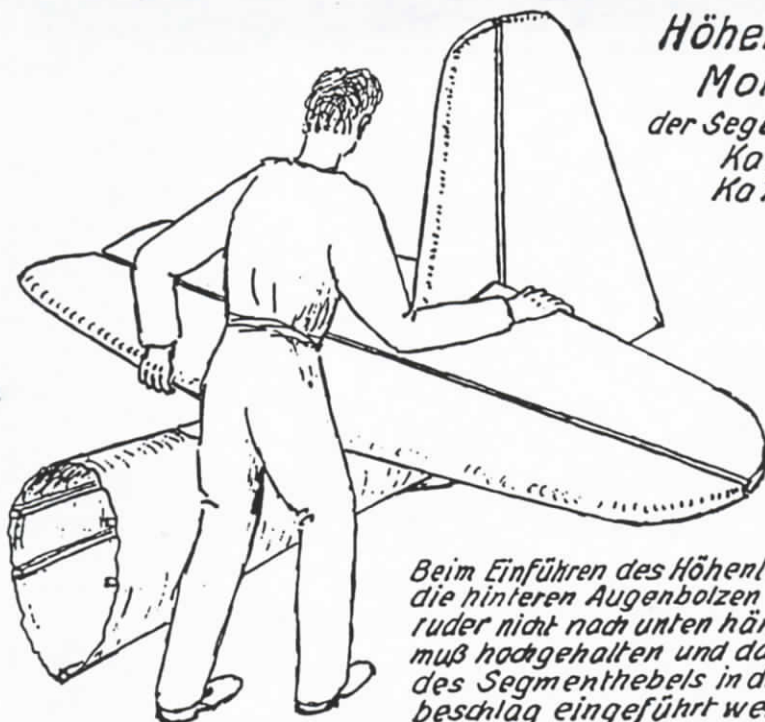
Beim Einführen des Höhenleitwerkes in die hinteren Augenbolzen darf das Höhenruder nicht nach unten hängen, sondern muß hochgehalten und das Kugellager des Segmenthebels in den U-Führungsbeschlag eingeführt werden!
